Monitoring the Green Innovation Grant Program

Environmental Facilities Corporation

Report 2017-S-19

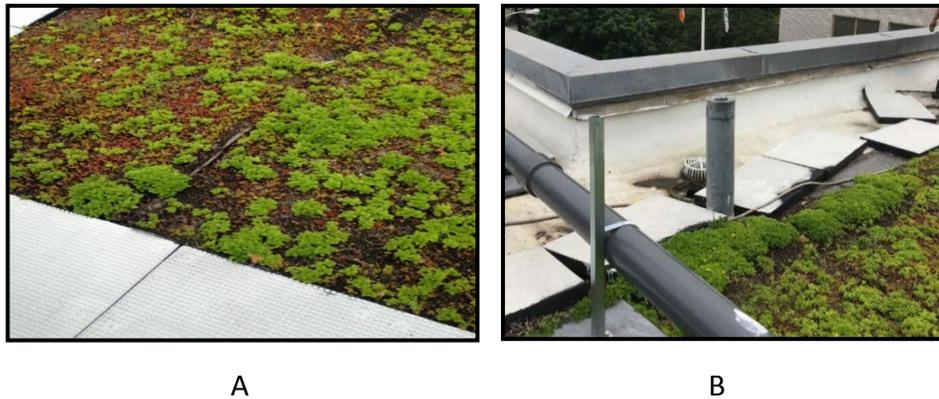
Figure 1 - NYC Parks-Bronx

- NYC Parks-Bronx (active): We observed that the green roof plant membrane that holds the plantings together was showing through the soil (Figure 1A), and the containment mats used to anchor the plantings and retain the soil were out of place, allowing soil

to wash down the drain (Figure 1B). The soil erosion could lead to damage to the plants' development and their root system necessary to absorb the rainwater, thereby compromising the benefit of this project.

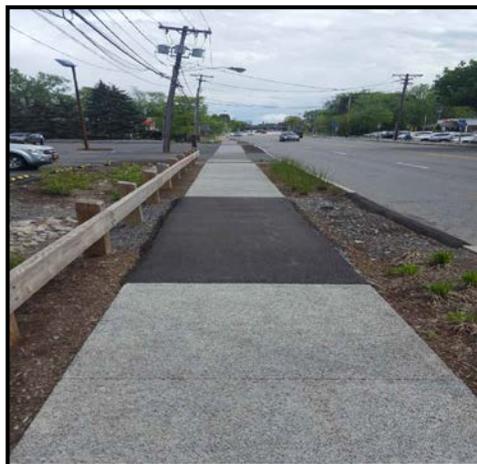
Figure 2 - Town of Brighton

- Bard College (completed): A small section (less than 5 percent) of the porous pavement parking lot was completed using non-porous materials, thus preventing water from infiltrating the pavement as intended.
- Town of Brighton (active): Adjoining landowners had seal-coated over a small section of porous pavement installed under the grant. Also, subsequent to a water main break, the Town had replaced a small section of porous sidewalk with non-porous materials (Figure 2). According to Corporation officials, after our site visit, the grantee subsequently made repairs with porous materials.

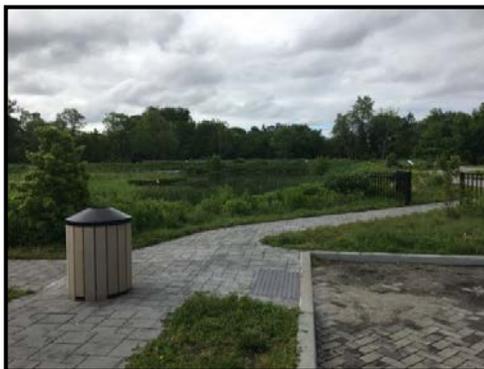
Figure 3 - Town of Brookhaven

- Town of Brookhaven (completed): Sand had built up on a small section of the porous interlocking pavers (Figure 3), which may inhibit some water from permeating the pavement.

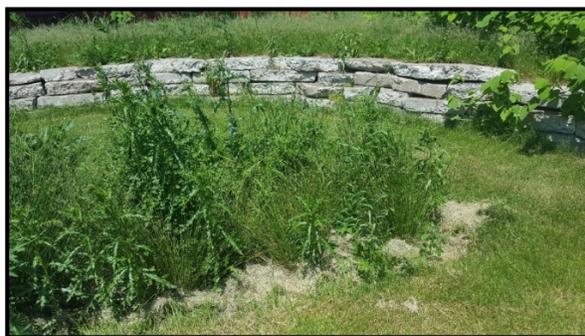
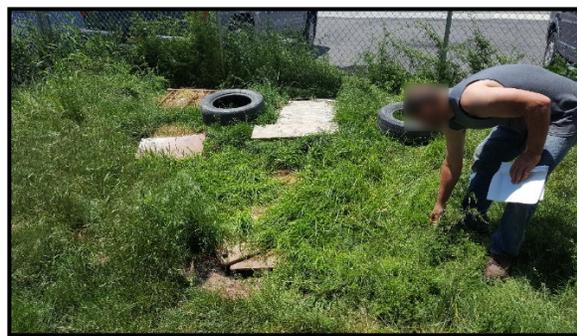
Figure 4 - BNSC

- BNSC (completed): Two rain gardens were severely overgrown (Figure 4A-B), one of which had debris such as tires and plywood dumped in it. It is unclear what effect, if any, the overgrowth may have on the functionality of the project. However, the unsightly appearance seems contrary to one of the Corporation's stated benefits of such projects: to help beautify streets and neighborhoods. Although BNSC's application stated that it intended to have long-term ownership or maintenance agreements to address its projects through their useful life, officials told us they do not maintain the project because they do not own it, which is contrary to both Agreement requirements and the statements in the application. There appears to be confusion between the grantee and the landowner as to which party will perform the necessary project maintenance.
